Volunteers Keeping A Watchful Eye on the Health of Maine Lakes and Ponds for 39 Years!

VLMP is the Largest Collector and Provider of Lake Data in the State of Maine

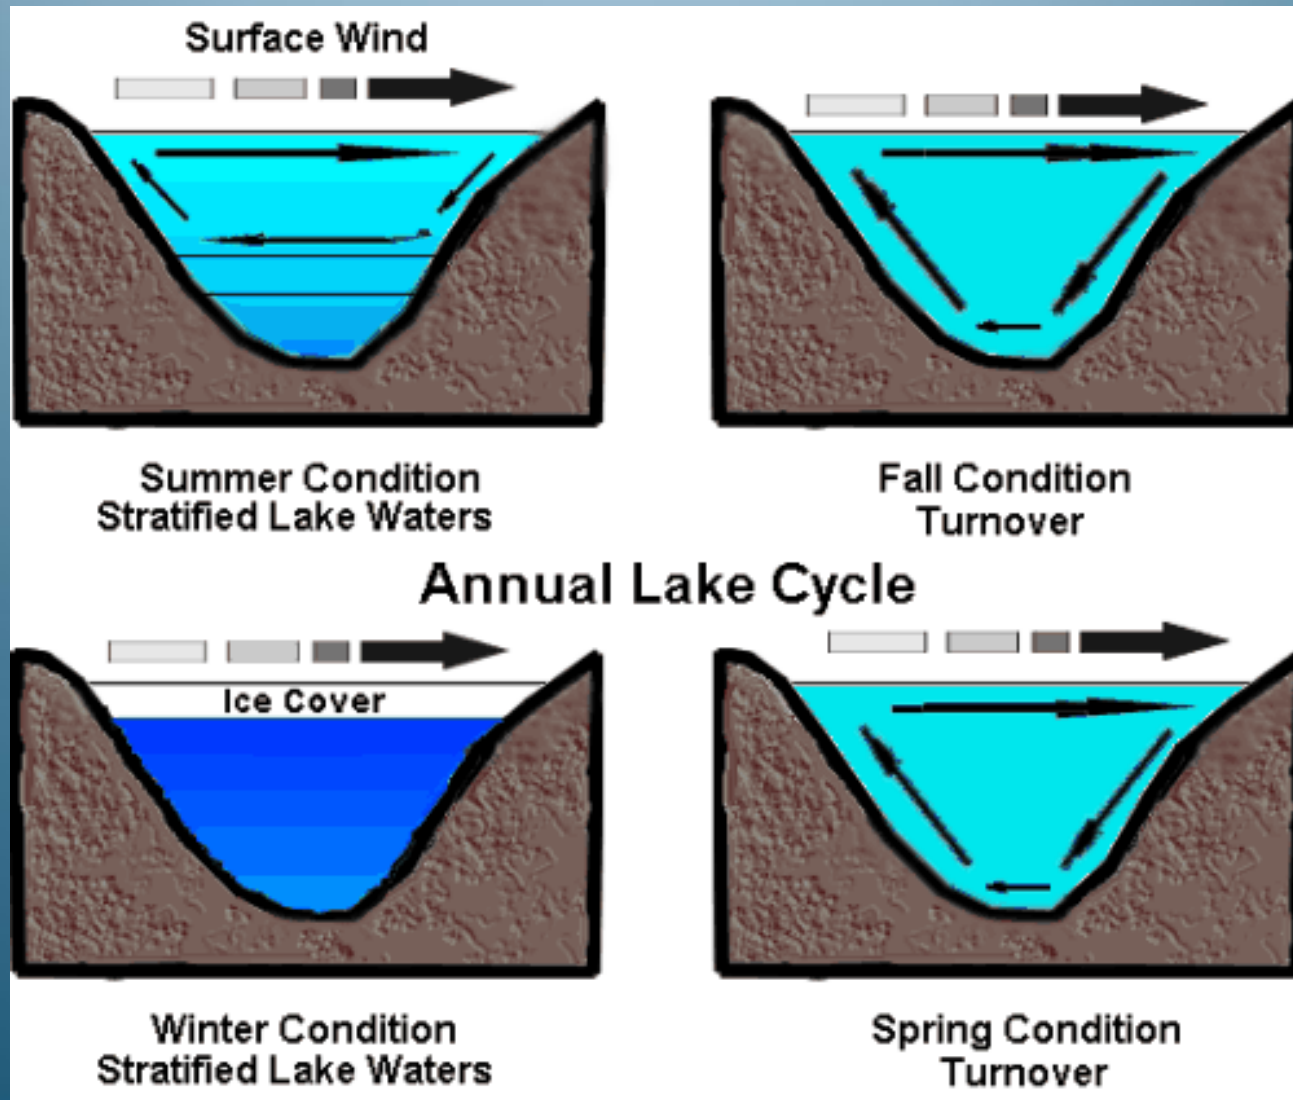
“Turnover” and Thermal Stratification

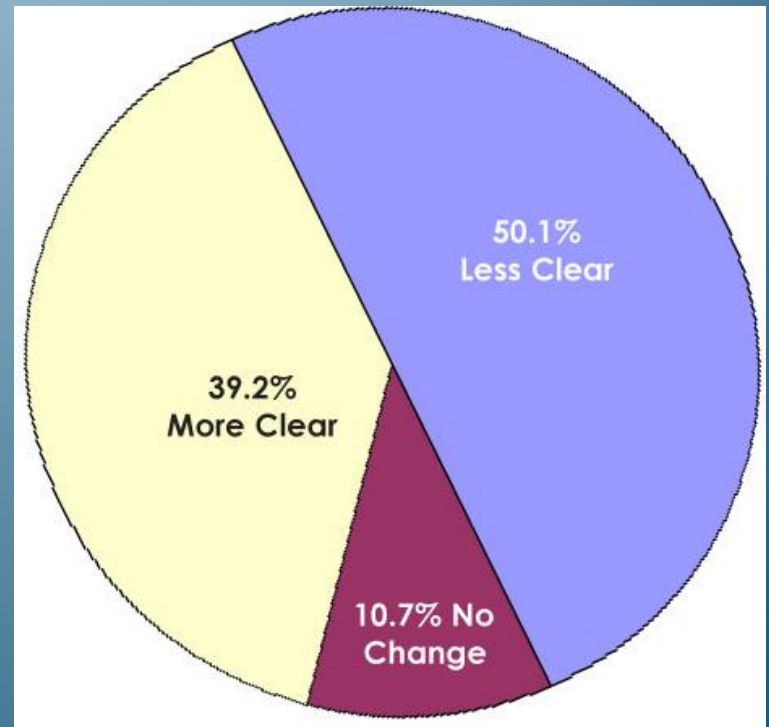
2009 457 Lakes

Transparency of Maine Lakes
